Machine
SRU Feed Pump A

Company Yinson Production	SFI/TAG 29PA5002A	Date 05-06-2025
Location JAK-FPSO	In Operation	Deviation Type Vibration
IMO Number	Running Hours	Approved By Thor-Kenneth
Class	Machine Interval 3M	Analysed By Herman Sandvik

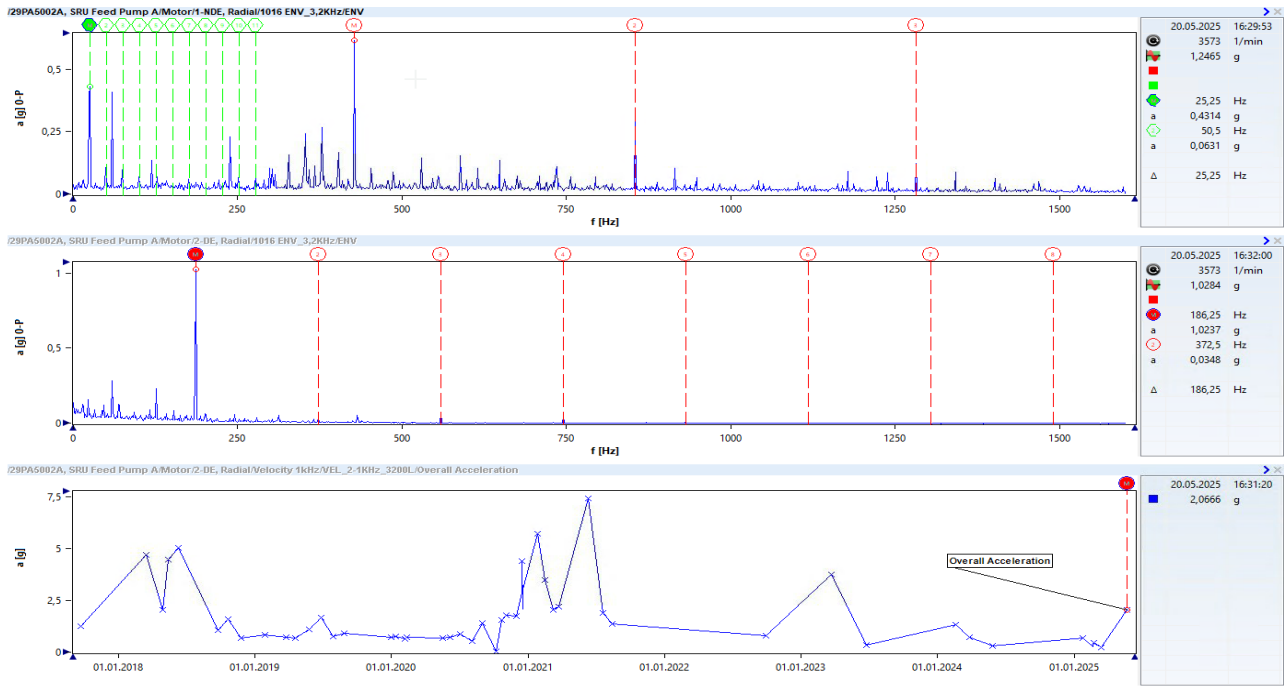
Findings	Machine Component	Diagnostic	Severity	Prognostic & RUL	Confidence
No. 1	Motor	Bearing wear S3	S3	RUL = <5% of L10 bearing life [limited]	75% or Higher
No. 2	Motor NDE	Bearing wear S2	S2	RUL = <10% of L10 bearing life [reduced]	75% or Higher
No. 3	Pump	Bearing wear S1	S1	RUL = <20% of L10 bearing life [reduced]	75% or Higher

The analysis shows a non-synchronous frequency of 3,1X with very high values and harmonics which can indicate a bearing defect. The frequency is visible in the Velocity FFT with harmonics. Values have increased suddenly since last measurement. This indicates a severe bearing defect.

The analysis shows a non-synchronous frequency of 7,11X with 1X sidebands with strong harmonics and moderate values. This can indicate a BPFI defect. The analysis also shows a sub-synchronous frequency of 0,42X with harmonics and moderate values which can indicate a FTF defect. Values have suddenly increased since last analysis.

The Envelope FFT still shows a non-synchronous frequency of 4,9X which match with a defect frequency of 6318 bearing. Our documentation does not confirm that this is the correct bearing. Values are low and stable, but should be monitored.

1. At this stage we recommend to replace the bearing at next opportunity, even though there are some remaining bearing life.
2. If the machine needs to be kept in operation, close follow-up is needed (temperature, noise, reduce load, lubricate etc.).
3. Measurement interval is set to 2 weeks.
4. Check maintenance history for the machine. If the bearing wear is considered to be premature, make sure you perform a RCFA of the bearing.

1. If the bearing is grease lubricated, please add 50% of normal amount of grease asap, if not done recently (within the last 3 months).
2. Machine can be operated as normal.
3. Plan the repair, order spares etc.
4. Follow the pre-defined measurement interval, but not more than 1000 hrs.

1. If the bearing is grease lubricated, make sure the lubrication program is followed.
2. Machine can be operated as normal. Follow the pre-defined measurement interval.
